Manhole Inspection Summary

Manhole # S19II_039MH

Insp Date: **6/20/07 12:09 PM**

Location Address: **2101 PULASKI ST**

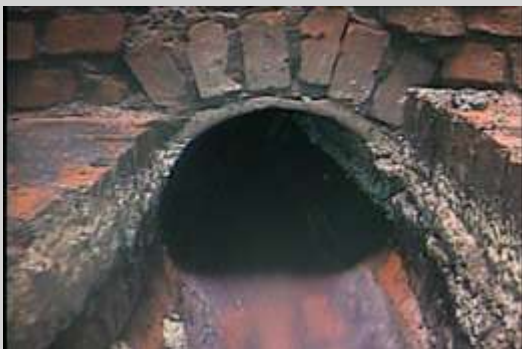
3 O'Clock Inflow

12 in. Circular Gravity Sewer
Pipe In @ 3 O'Clock

Pipe Height: **13.2** (in.) Rod and Bar (Angled)
Pipe Material: **Clay** ☐ Pipe Lined
Invert Depth: **13.74** (ft.) Flow Characteristics: **Fast**
Deposits: ☒ **None** ☐ Mud ☐ Sludge ☐ Debris ☐ Grease
Silt Depth: (in.) Deposits Extent:
Infiltration: **None** Pipe Seal Cond: **Sound**

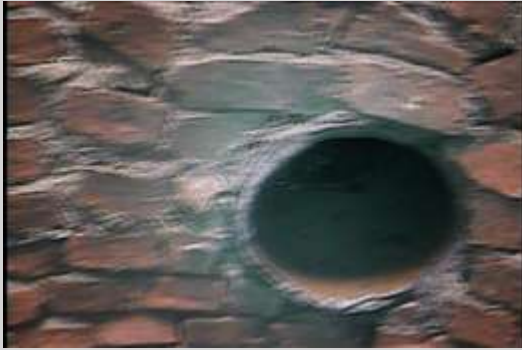
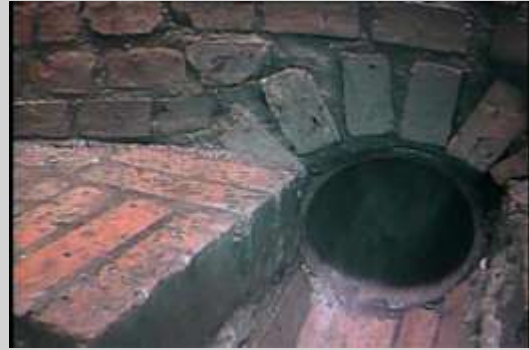
6 O'Clock Inflow

8 in. Circular Gravity Sewer

Pipe In @ 6 O'Clock

Drop In @ 6 O'Clock

Pipe Height: **8.4** (in.) Rod and Bar (Angled)

Infiltration: **None** Pipe Seal Cond: **Sound**

Drop Condition: **Open**
